PHASE I REPORT
NATIONAL DAM SAFETY PROGRAM
TENNESSEE

Name of Dam Jennings Creek Watershed Dam # 16
County Macon
Stream Trib. of Jennings Creek at Donoho Hollow
Date of Inspection ... January 8, 1981

PHASE I INSPECTION REPORT
NATIONAL DAM SAFETY PROGRAM
TENNESSEE

PHASE I INSPECTION REPORT
NATIONAL DAM SAFETY PROGRAM
JENNINGS CREEK WATERSHED DAM NO. 16
MACON COUNTY, TENNESSEE

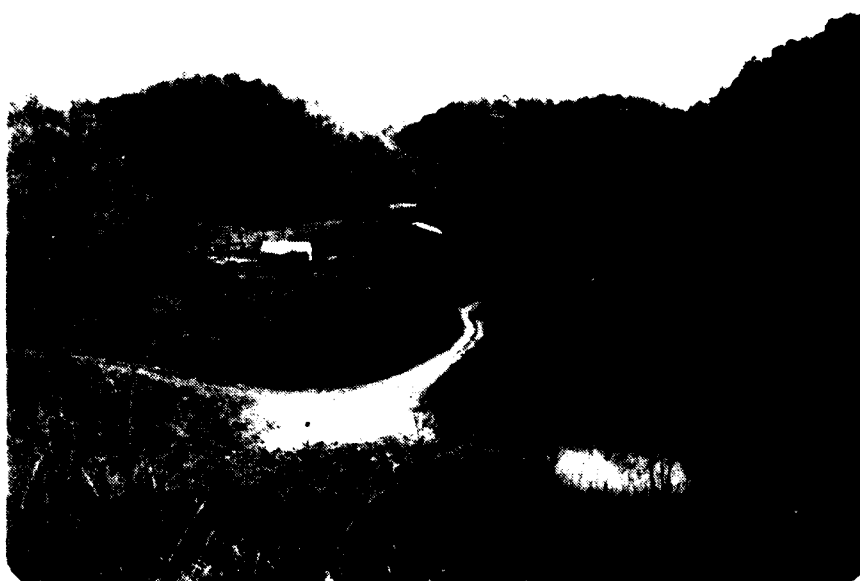
PHOTO NO. 5

- 2.3 Size and Hazard Classification - The dam is in the intermediate size classification, with a measured height of 47.1 feet. Reservoir storage is calculated as 41 acre-feet at normal pool and 400 acre-feet at maximum pool (top of dam). The dam is classified as high hazard because of the presence of a house several hundred feet downstream of the dam (see photo no. 5).

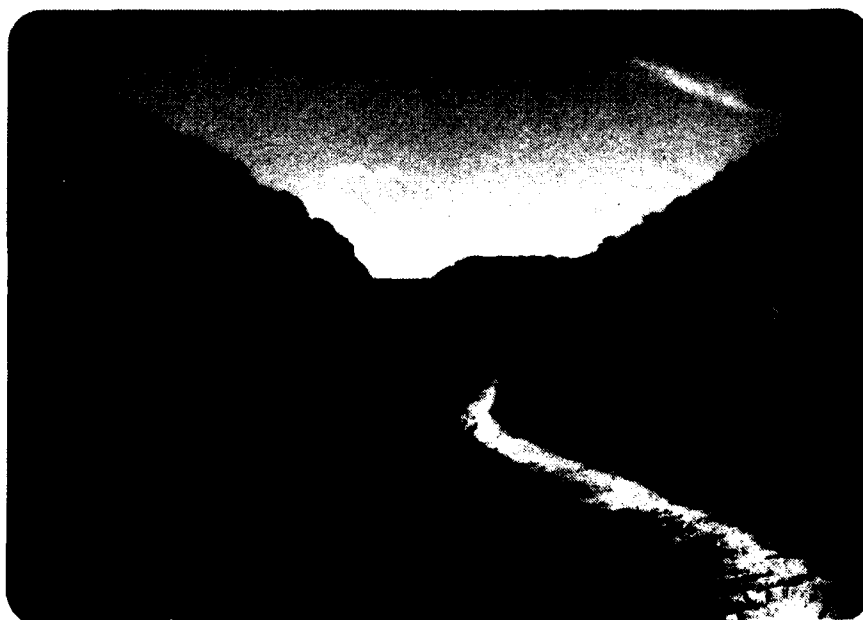
PHOTO NO. 6

- 3.1.1 Embankment - The dam is well grassed and free of deleterious vegetation except for a few copse along the downstream toe and scattered other locations. The crest and side slopes are uniform and well defined, exhibiting no signs of instability. No cracks, indications of seepage, sliding, or differential settlement were observed on the dam or in the area immediately downstream. Erosion from surface runoff is insignificant (See photo no. 6).

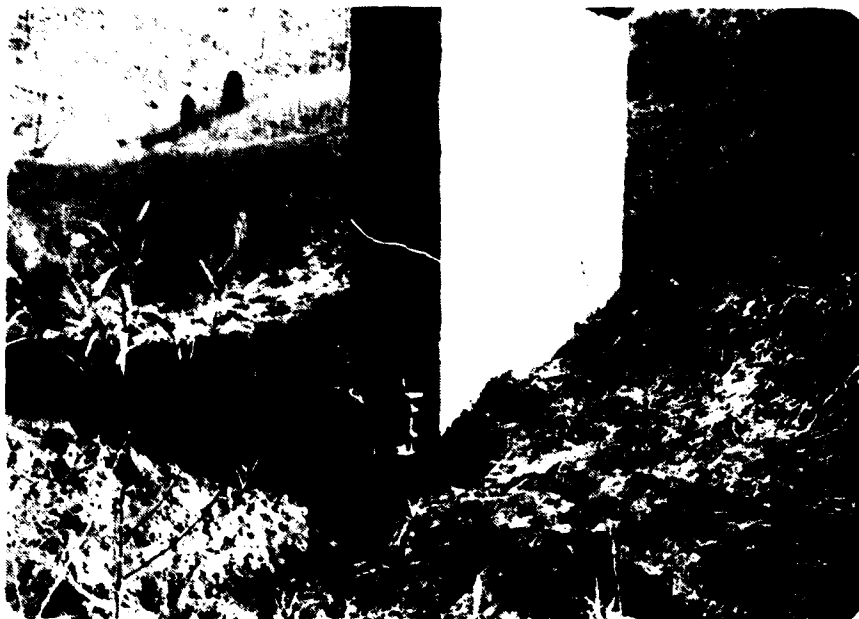
PHOTO NO. 7

- 3.1.2 Service Spillway - The riser appears to be in excellent condition with no noteworthy cracking or weathering. The drawdown gate and operating mechanism have been recently installed and appear to be operable (see photo no. 7). The spillway culvert is presumably in good condition also as evidenced by the appearance of the outfall (see photo no. 8).
